Reigh R. Granlund
FAA Designated Airworthiness Representative

November 20, 2013

BEEHCRAFT BARON E55 N138TL

ENGINE TEARDOWN TECHNICAL INSPECTION REPORT

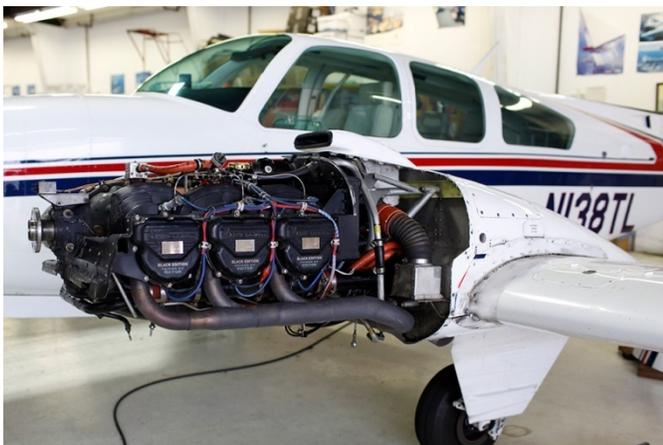
#12457 (S/N 267651-R) Left Engine

1. Prior to the engine disassembly the condition of the exterior of the engines were documented in the as removed condition. Signs of cosmetic wear to engine cylinder baffling, installation hoses, and some chaffing marks were noted which is normal to an engine installation. General condition of engines exterior enamel paint and black electrostatic powder coating on engine crankcases, cylinders, and valve covers was above average with no signs of corrosion. The black electrostatic powder coating material that was originally applied at overhaul was not chipping or faded and showed superb bonding to the aluminum engine surfaces still reflecting a gloss finish. All twelve of the engines cylinder assemblies are the original cylinders that were installed by Victor Aviation and have never been replaced or rebuilt since overhaul of the engines were performed on December 8th, 2000.

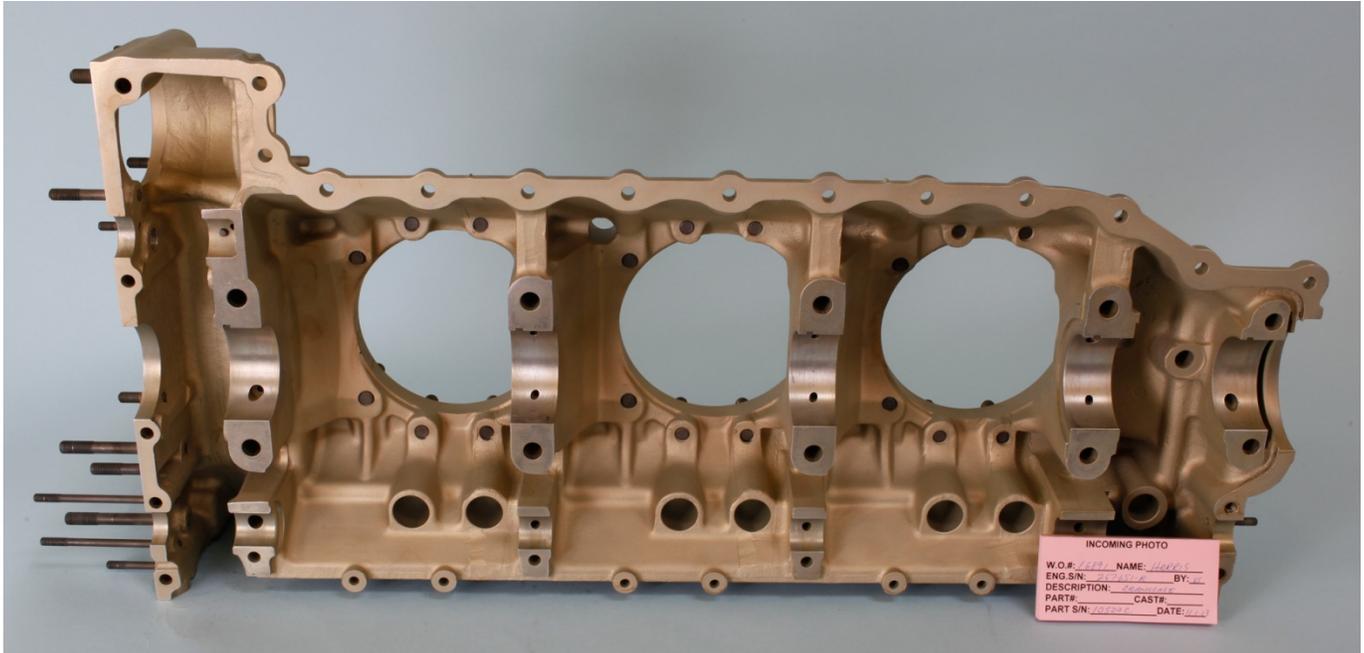
2. Inspection and observation of the disassembled engines were impressive. The engines crankcases, cylinders and pistons showed no defects, signs of overheat or cracking. Engine crankcases were in good condition with no cracks or corrosion observed and no fretting on the crankcase parting surfaces or indications of any bearing movement. Piston rings were free and rotating in all piston ring lands and some cylinders still showed the machined barrel surface cross hatch marks from the original cylinder machining at Victor Aviation with minimum barrel wear observed.

After Black Electrostatic Powder Coating Removed - Crankcase ENGINE S/N 267651-R

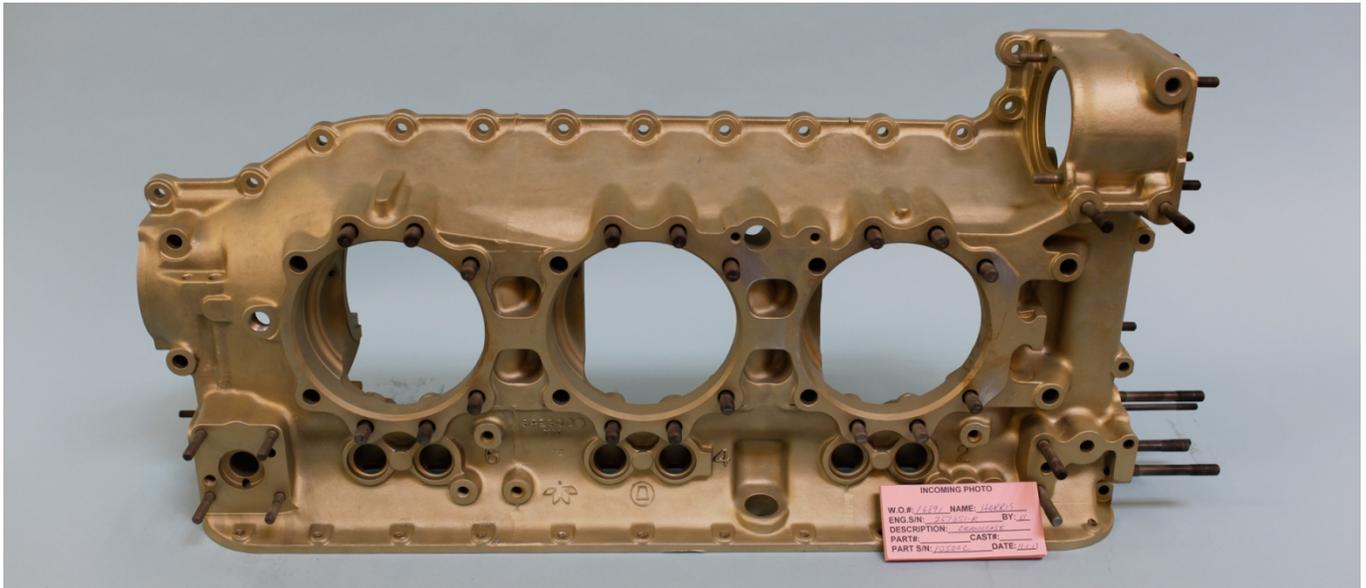
After Black Electrostatic Powder Coating Removed - Crankcase ENGINE S/N 267651-R

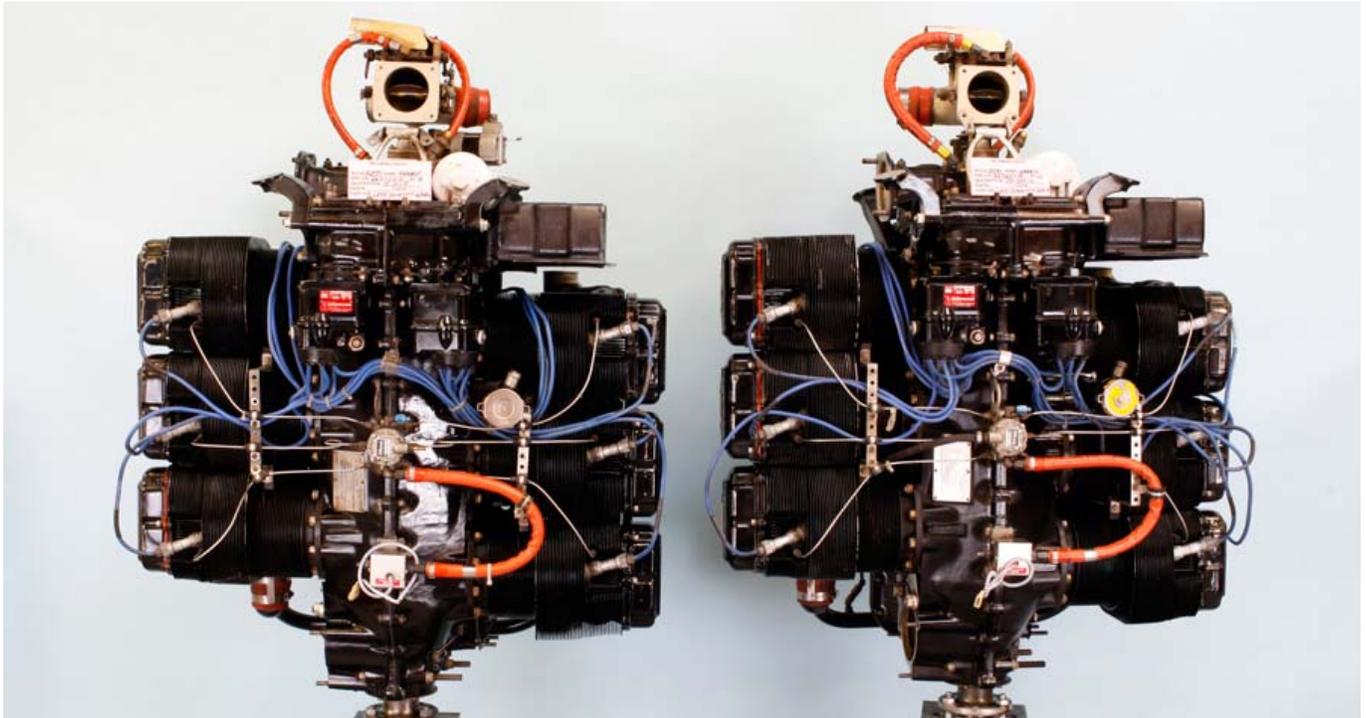
LEFT ENGINE S/N 267651-R 1,879.5 hours SMOH

- 3. Both of the engine’s crankshafts, counterweights, counterweight bushings, counterweight pins and plates dimensions were measured and checked and still remain within the engine manufacturer’s new parts limits and wear was minimally detectable. This would indicate a very high degree of engine balancing was performed on these engines.

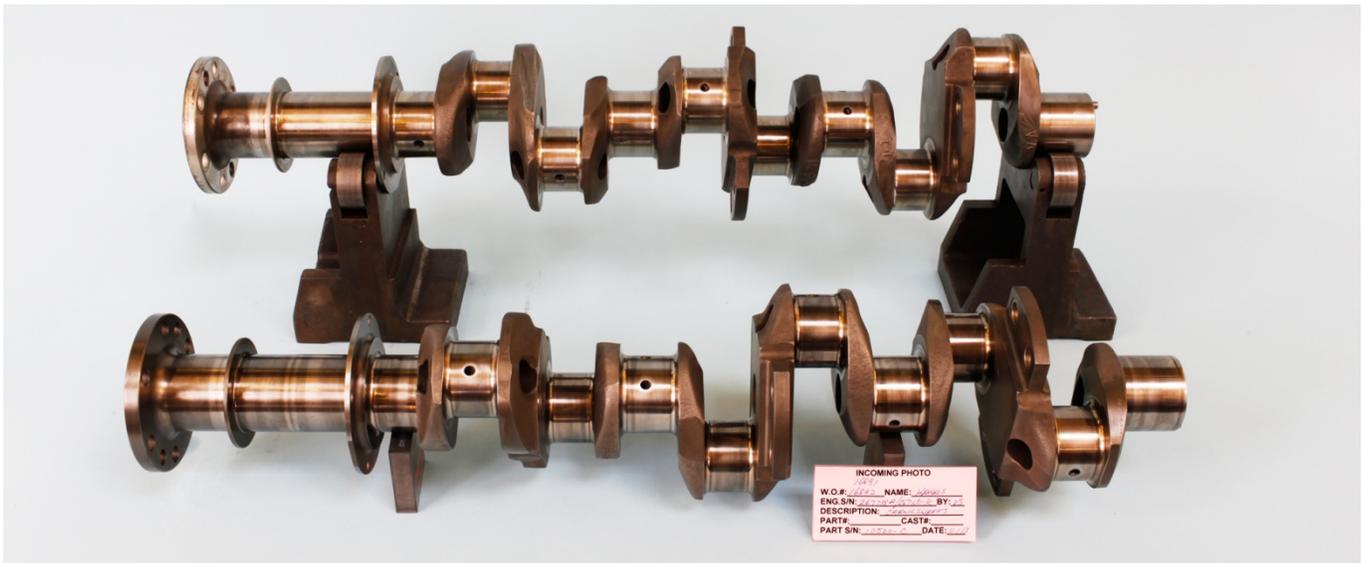
Top - Crankshaft S/N C219702N

Crankshaft Connecting Rod Journals

Factory New Parts Limits: Maximum 2.250 Minimum 2.249 Service Limit 2.247

#1 - 2.2491 #2 - 2.2492 #3 - 2.2493 #4 - 2.2493 #5 - 2.2492 #6 - 2.2493

#1 - 2.2495 #2 - 2.2495 #3 - 2.2495 #4 - 2.2494 #5 - 2.2494 #6 - 2.2494

Factory New Parts Limits: Maximum 2.375 Minimum 2.374 Service Limit 2.372

#1-2.3741 #2-2.3741 #3-2.3742 #4-2.3741 #5-2.3741 #6-2.3741

#1-2.3742 #2-2.3743 #3-2.3744 #4-2.3745 #5-2.3744 #6-2.3744

Bottom - Crankshaft S/N 860632U

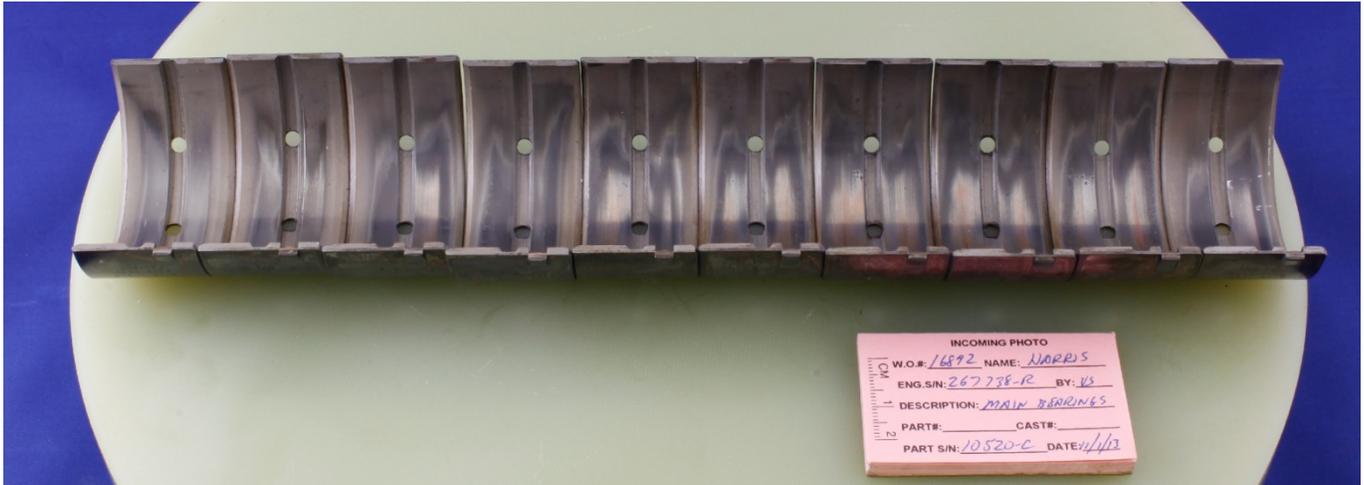
Main Crankshaft Bearing Part # SA-642839 ENGINE S/N 267738-R

Factory New Specification: .094

Main Bearings Measured: .0936 - .0933 Engine S/N 267738-R

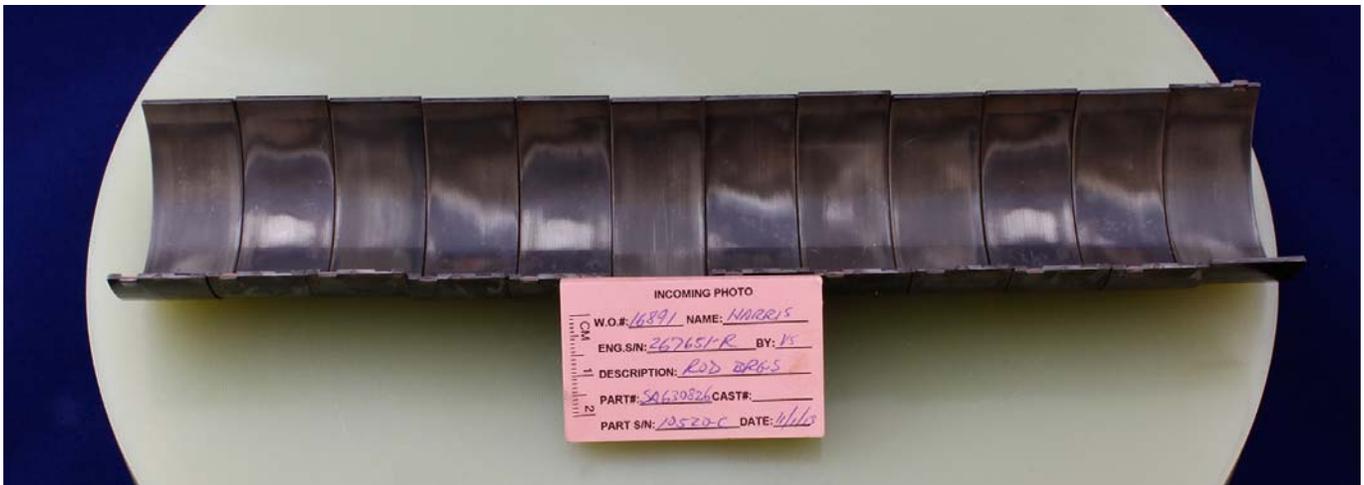
Connecting Rod Bearing Part # SA-630826 ENGINE S/N 267651-R

Factory New Specification: .0623

Rod Bearings Measured: .0617 - .0622 Engine S/N 267651-R

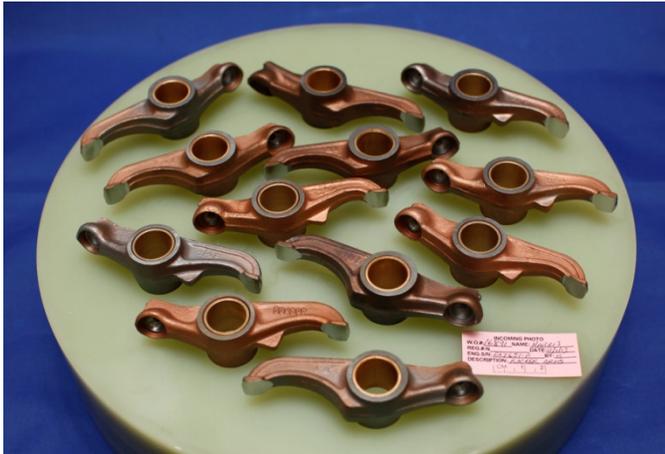
Rocker Arms S/N 267651-R

Factory New Specification: .749 - .7495
 Shafts Measured: .7487 - .749 Engine S/N 267651-R
 Shafts Measured: .7487 - .749 Engine S/N 267738-R

4. Hydraulic lifters, engine gears, camshaft and all internal engine bearings showed little wear. No spalling, pitting or corrosion was found on the engine's camshaft or hydraulic lifter assemblies. No corrosion or pitting was observed on the engine's gears. Valve rocker arms were in good condition with no wear indications and smooth rocker tip machined surfaces.

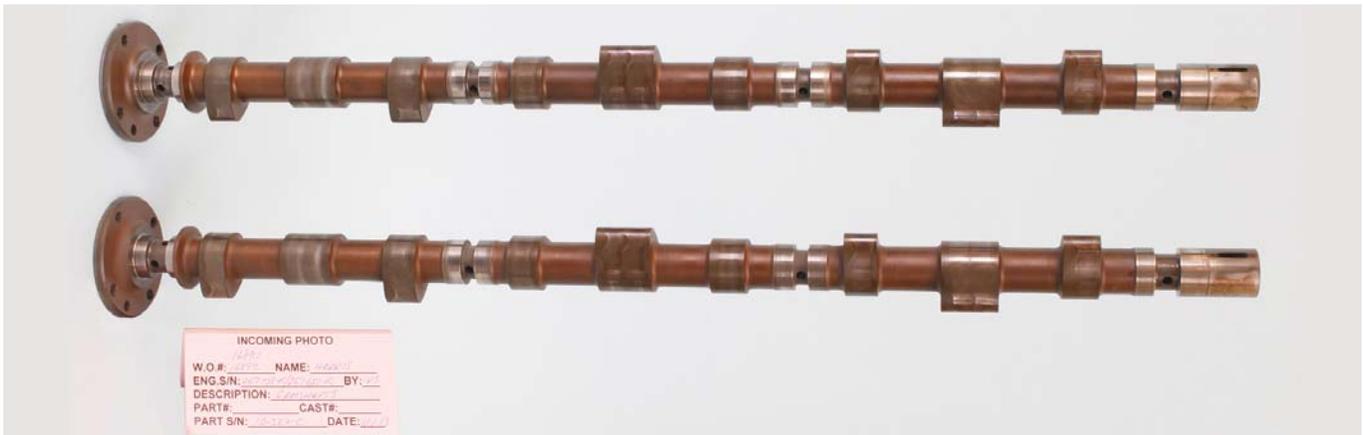
Top - Camshaft S/N 267651-R

Factory New Limits: .096 - .097
 Journals Measured: .096 - .0965 Engine S/N 267651-R
 Journals Measured: .096 - .0965 Engine S/N 267738-R

Bottom - Camshaft S/N 267738-R

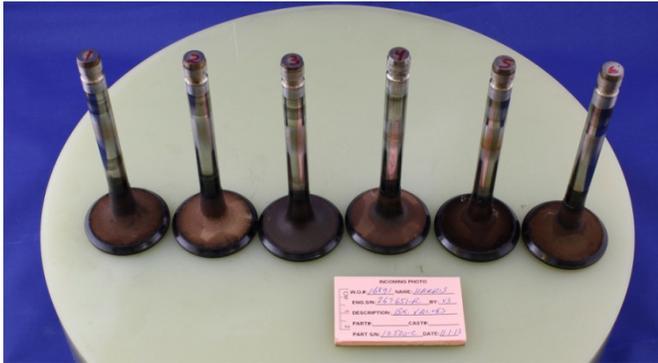
Exhaust Valves S/N 267651-R

Factory New Limits: Minimum .4335 Maximum .434

Valve Stem Measurements: #1- .433 #2- .4334 #3- .4331 #4- .4334 #5- .433 #6- .4332

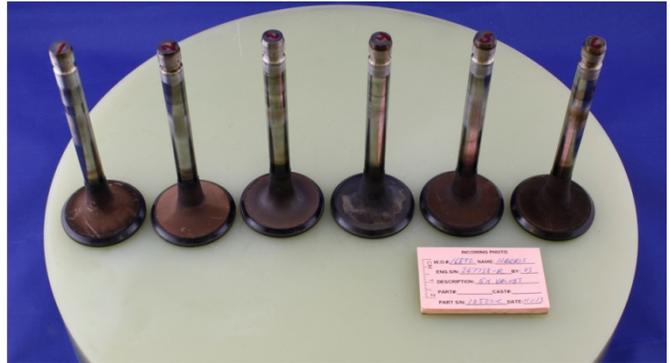
Exhaust Valves S/N 267738-R

Valve Stem Measurements: #1- .4332 #2-.4331 #3- .4331 #4- .4332 #5- .4331 #6-.4333

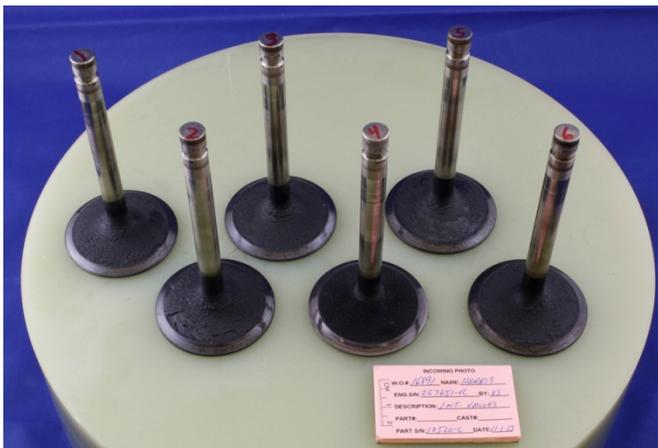
Exhaust Valves S/N 267651-R

Factory New Limits: Minimum .4335 Maximum .434

Valve Stem Measurements: #1- .4336 #2- .4337 #3- .4337 #4- .4336 #5- .4337 #6- .4337

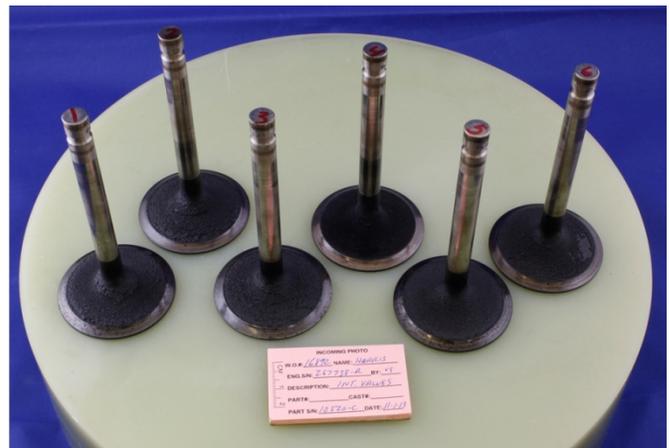
Exhaust Valves S/N 267738-R

Valve Stem Measurements: #1- .4337 #2- .4337 #3- .4336 #4- .4337 #5- .4337 #6- .4336

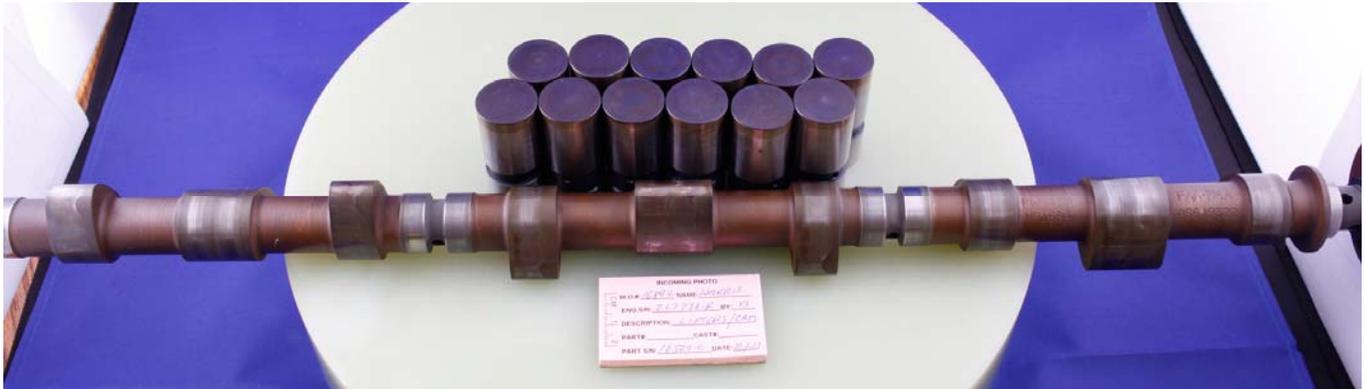
Camshaft Part #649322 Lifters Part # 653877, 653888 ENGINE S/N 267738-R

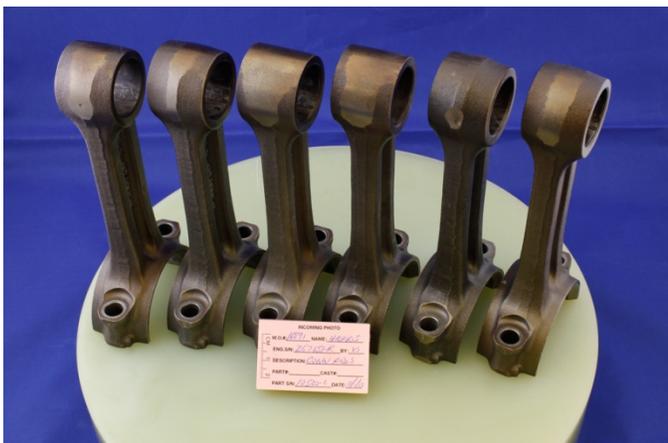
Connecting Rods S/N 267651-R

5. Dimensional check of all internal engine parts were measured to still be within the original manufacturers new parts limits listed under Teledyne Continental Motors Overhaul Manual X30039 dated October, 2013.
6. Connecting rods were all in good condition with no signs of wear, fretting or misalignment.

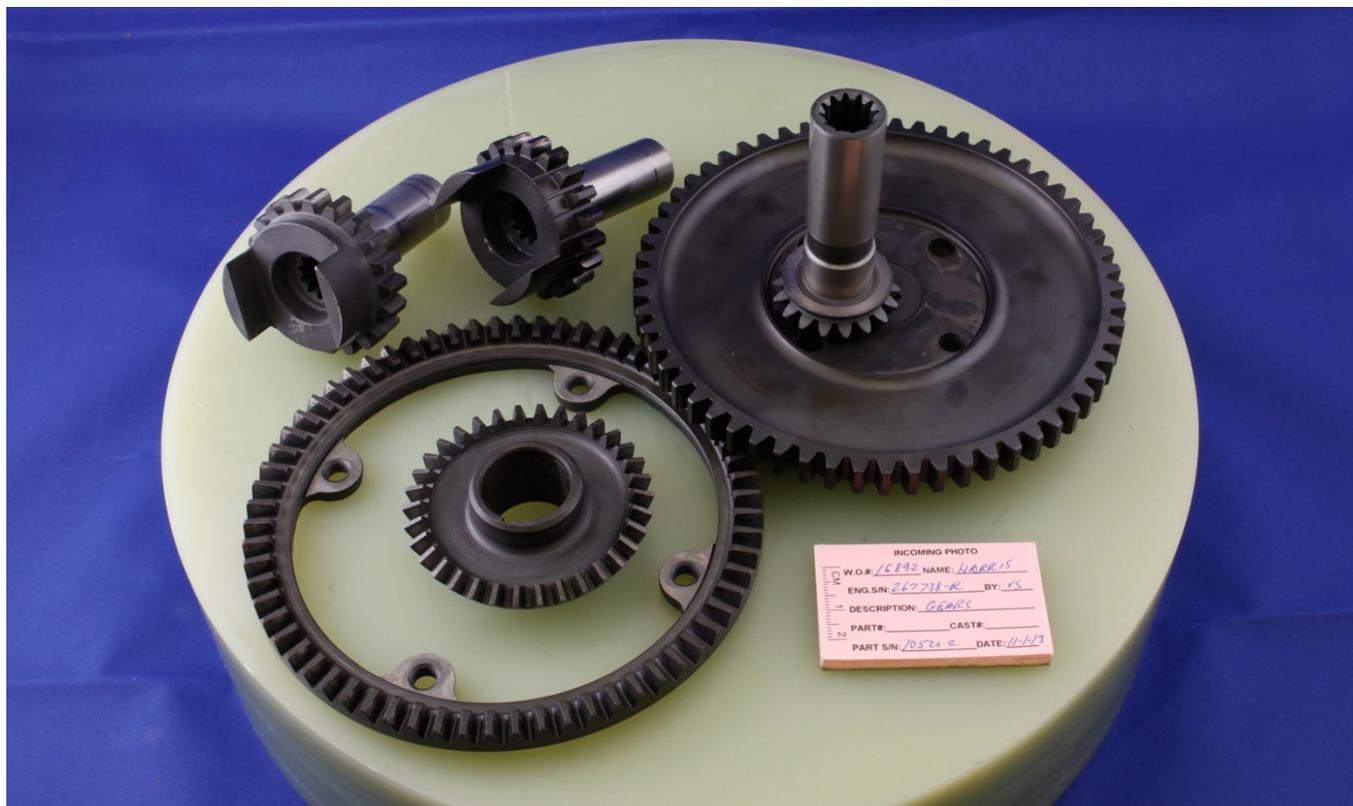
- One significant observed difference stood out. The internal engine gears listed below on these two IO-520-C engines observed, had been put through a process that impregnates a black iron manganese phosphate to them at overhaul by Victor Aviation. Wear and corrosion to these gears was nonexistent compared to the other randomly selected gear samples from similar model 520 engines.

Magneto & Accessory Drive Gear
 Oil Pump and Tach Shaft Gear
 Alternator Drive Face Gear

Governor Drive Bevel Gear
 Camshaft Bevel Gear
 Camshaft Gear

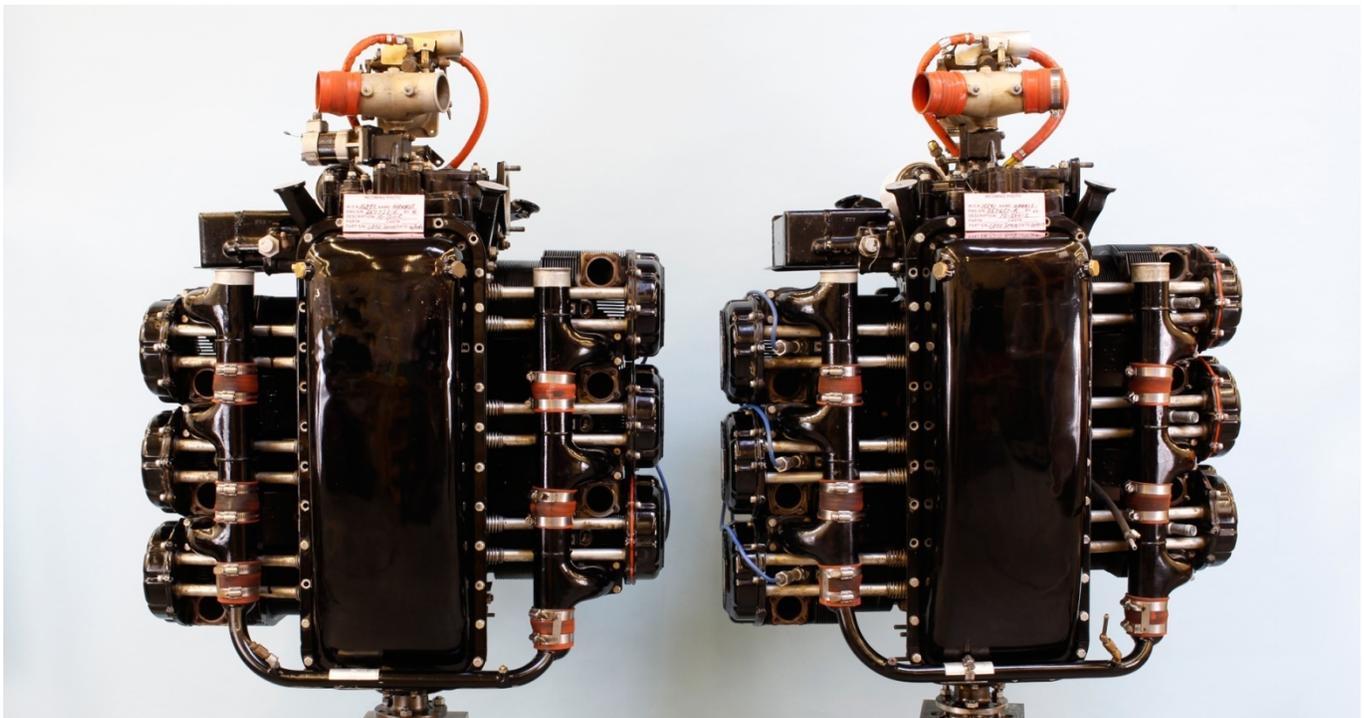
LEFT ENGINE S/N 267651-R 1,879.5 hours SMOH

9. According to Teledyne Continental Motors Service Instruction Letter #SIL98-9C, time between overhaul periods for an IO-520C engine model is 1,700 hours. These engines were operated beyond the manufacturers recommended (TBO) Time Between Overhaul.
10. Left and Right engines were documented to be 179.5 hours over TBO.
11. Left and right engine compression checks of all 12 cylinders were recorded normal throughout the 1,879.5 engine hours operated and within the manufacturers acceptable limit as per TCM03-3. The 12 cylinders have not had any replacement of valves, valve seats, springs, pistons or piston rings.

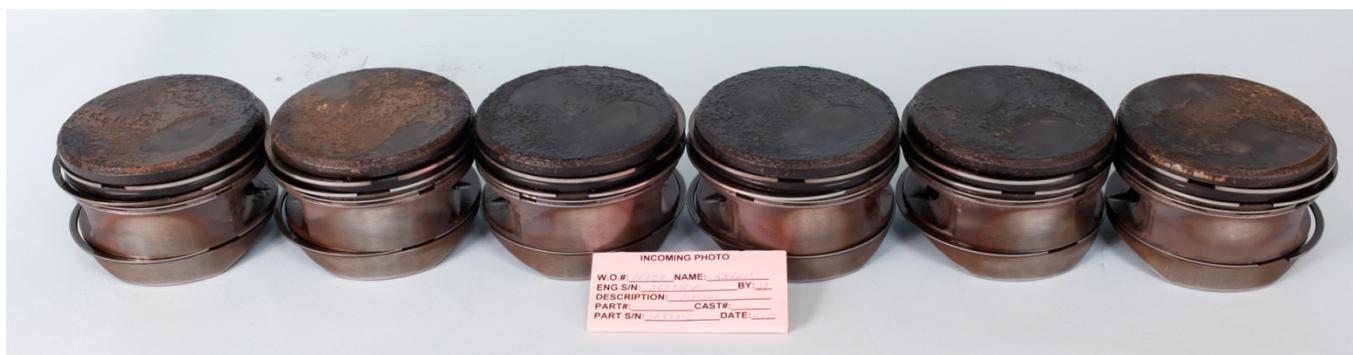
Superior Pistons Part # SA-648013 ENG S/N 267738-R

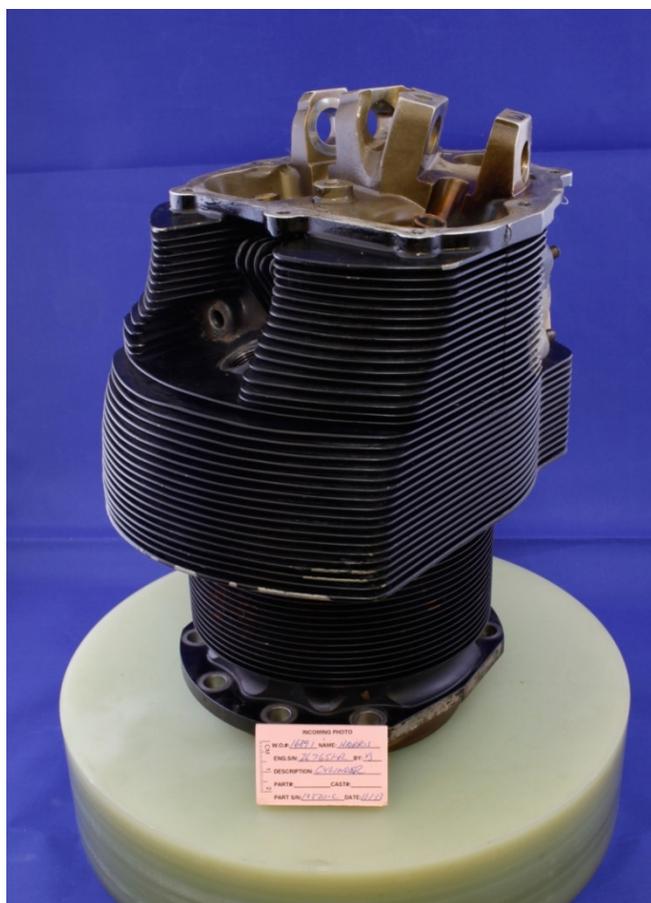
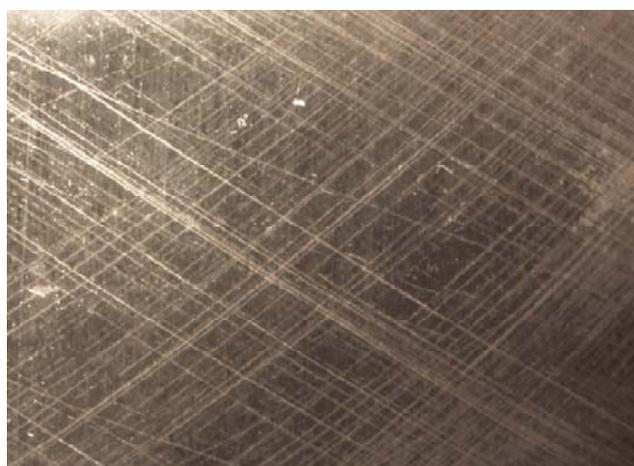
Left -
Superior Cylinder Part #SA5H52000-A1
ENG S/N 267651-R

Cylinder Bore Internal Diameters - Superior Part #SA5H52000-A1

Factory New Limits: Minimum 5.251 Maximum 5.253 Service Limit 5.256

Bore Diameters: #1- 5.253 #2- 5.253 #3- 5.253 #4- 5.253 #5 5.253 #6- 5.253

Bore Diameters: #1- 5.2525 #2- 5.2525 #3- 5.2525 #4- 5.2525 #5 5.2525 #6- 5.2525

Above - Inside View - Superior Cylinder Barrel Wall Surface Part #SA5H52000-A1 (Magnified View)
Cylinder bore surface showing cross-hatch machine marks.
